Technical Report CHL-97-25  
August 1997

# **Model Study of the Confluence of San Juan Creek and Trabuco Creek, Orange County, California**

## **Hydraulic Model Investigation**

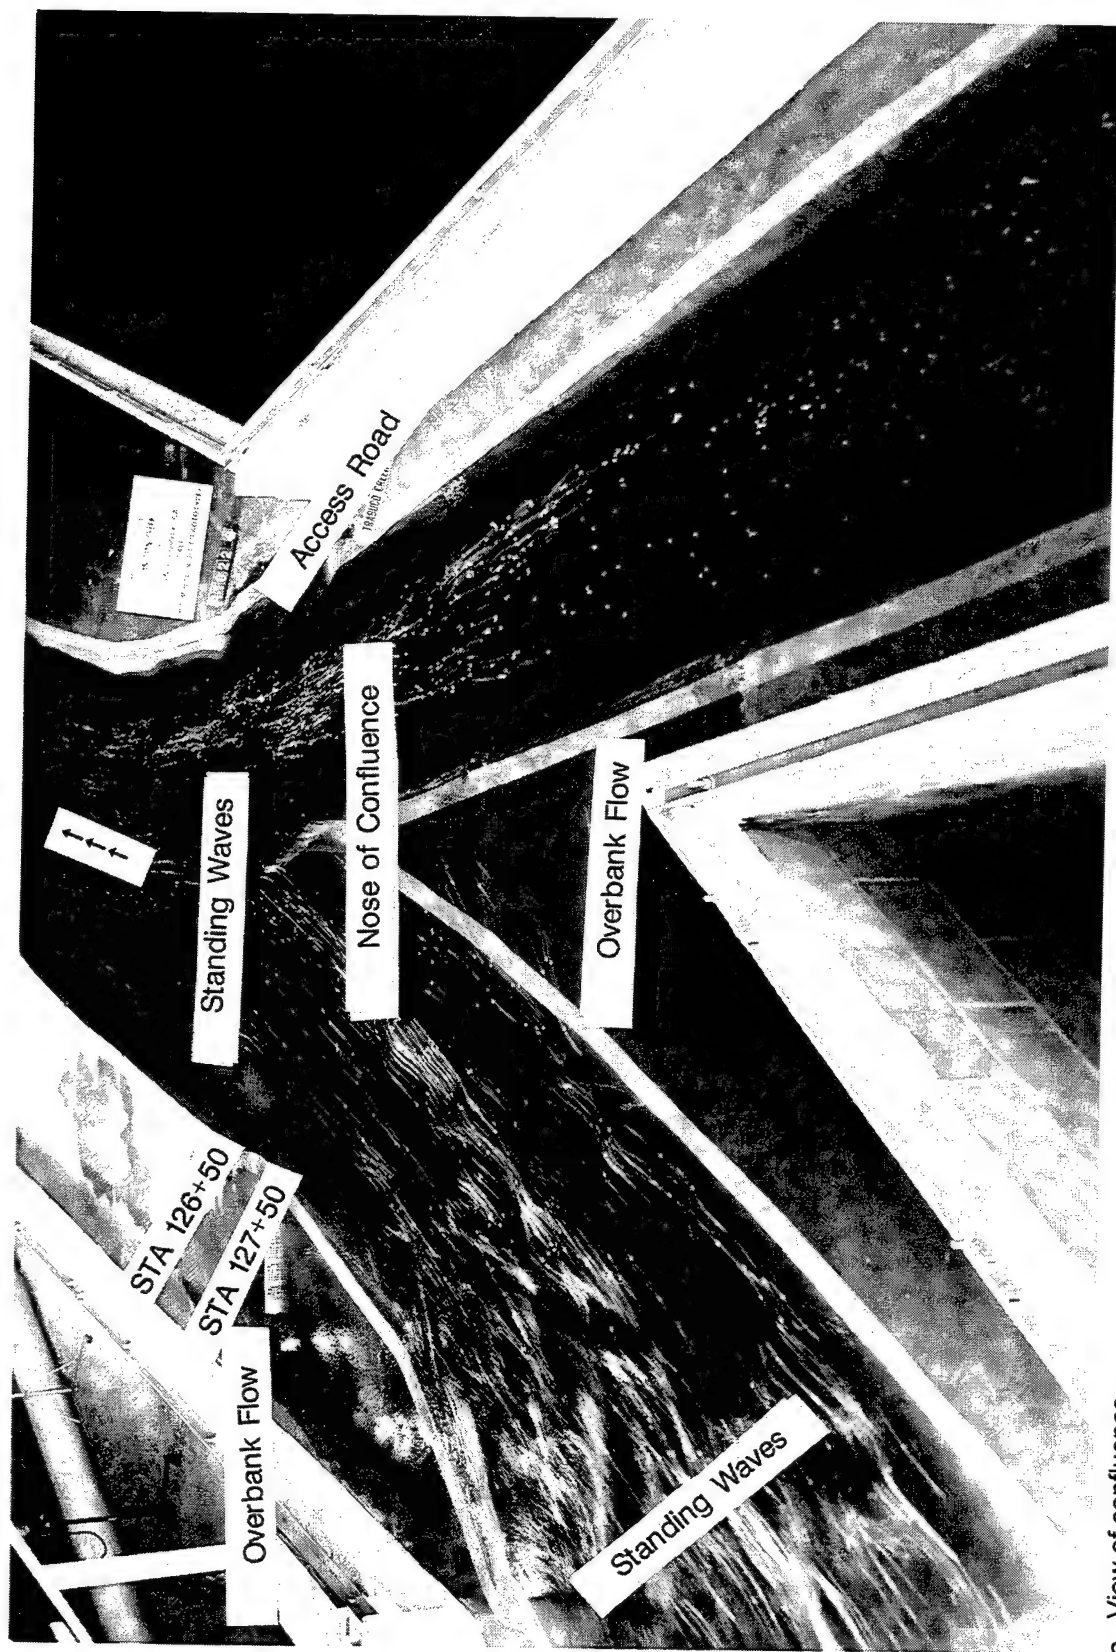
a. View of confluence

Photo 1. San Juan Creek, type 1 design, looking downstream at the confluence with Trabuco Creek, design discharges  $Q_{sj}$  42,000 cfs (1,176 cu m/sec);  $Q_{tr}$  17,000 cfs (476 cu m/sec). Standing waves observed by the railroad bridge piers and the abrupt expansion of the channel width. Overbank flow was also observed along the left and right banks. (Continued)

Flow conditions observed in the San Juan Creek for the design discharges indicated that the flow was contained within its banks both upstream and downstream of the confluence. However, at the confluence, flow spilled over into Trabuco Creek along the right embankment (west levee) at sta 134+00 (Photo 1a). Flow overtopped the left embankment (east levee) between sta 133+00 and sta 126+50 (Photo 1a). Standing waves of approximately 2 to 3 ft (0.6 to 0.9 m) in height (measured from peak to trough) were observed downstream of the railroad bridge piers and were created by the bridge piers (Photo 1b). Water-surface profiles recorded for the design discharges in both San Juan (42,000 cfs (1,176 cu m/sec)) and Trabuco (17,000 cfs (476 cu m/sec)) Creeks are shown in Plates 2 and 3. Water-surface elevations used to plot the water-surface profiles are given in Table 1. Velocities measured in Trabuco Creek 1 ft (0.3 m) above the bottom are shown in Plates 4 and 5 and in San Juan Creek, Plates 6 and 7. Bottom velocities measured at the confluence are shown in Plate 8. Oblique standing waves were observed between the San Diego Freeway bridge piers, and the surface flow concentrated in the center of the bridge piers as shown by the confetti in Photo 2a. A standing wave was

observed originating along the left bank (east levee) at sta 126+50 and extending diagonally toward the right bank (west levee) (Photo 1a). This wave was caused by the abrupt expansion of the channel width from sta 127+30 to sta 126+50 (Photo 1a). A small standing wave was observed at the nose of the confluence at sta 128+00 and is shown in Photo 1a. The access road on San Juan Creek (Photo 1b) was completely submerged and did not affect flow conditions. Satisfactory flow conditions were observed in Trabuco Creek upstream from the junction with San Juan Creek for the design discharges. Four existing grade stabilizers, with grouted rock attached to the channel slopes, are located at sta 50+37, sta 42+75, sta 30+50, and sta 18+25. The water-surface profile (Plate 3) indicates that the flow depth increases upstream of each grade stabilizer and decreases downstream. Oblique standing waves observed downstream of each grade stabilizer were created by the grouted rock "wings" (Photo 3a). For the design discharges, the flow depth in Trabuco Creek increased significantly at the confluence (Plate 3), and small standing waves were observed due to the overflow from San Juan Creek (Photo 1a). The access road on Trabuco Creek at the confluence also contributed to the generation of standing waves (Photo 1a).

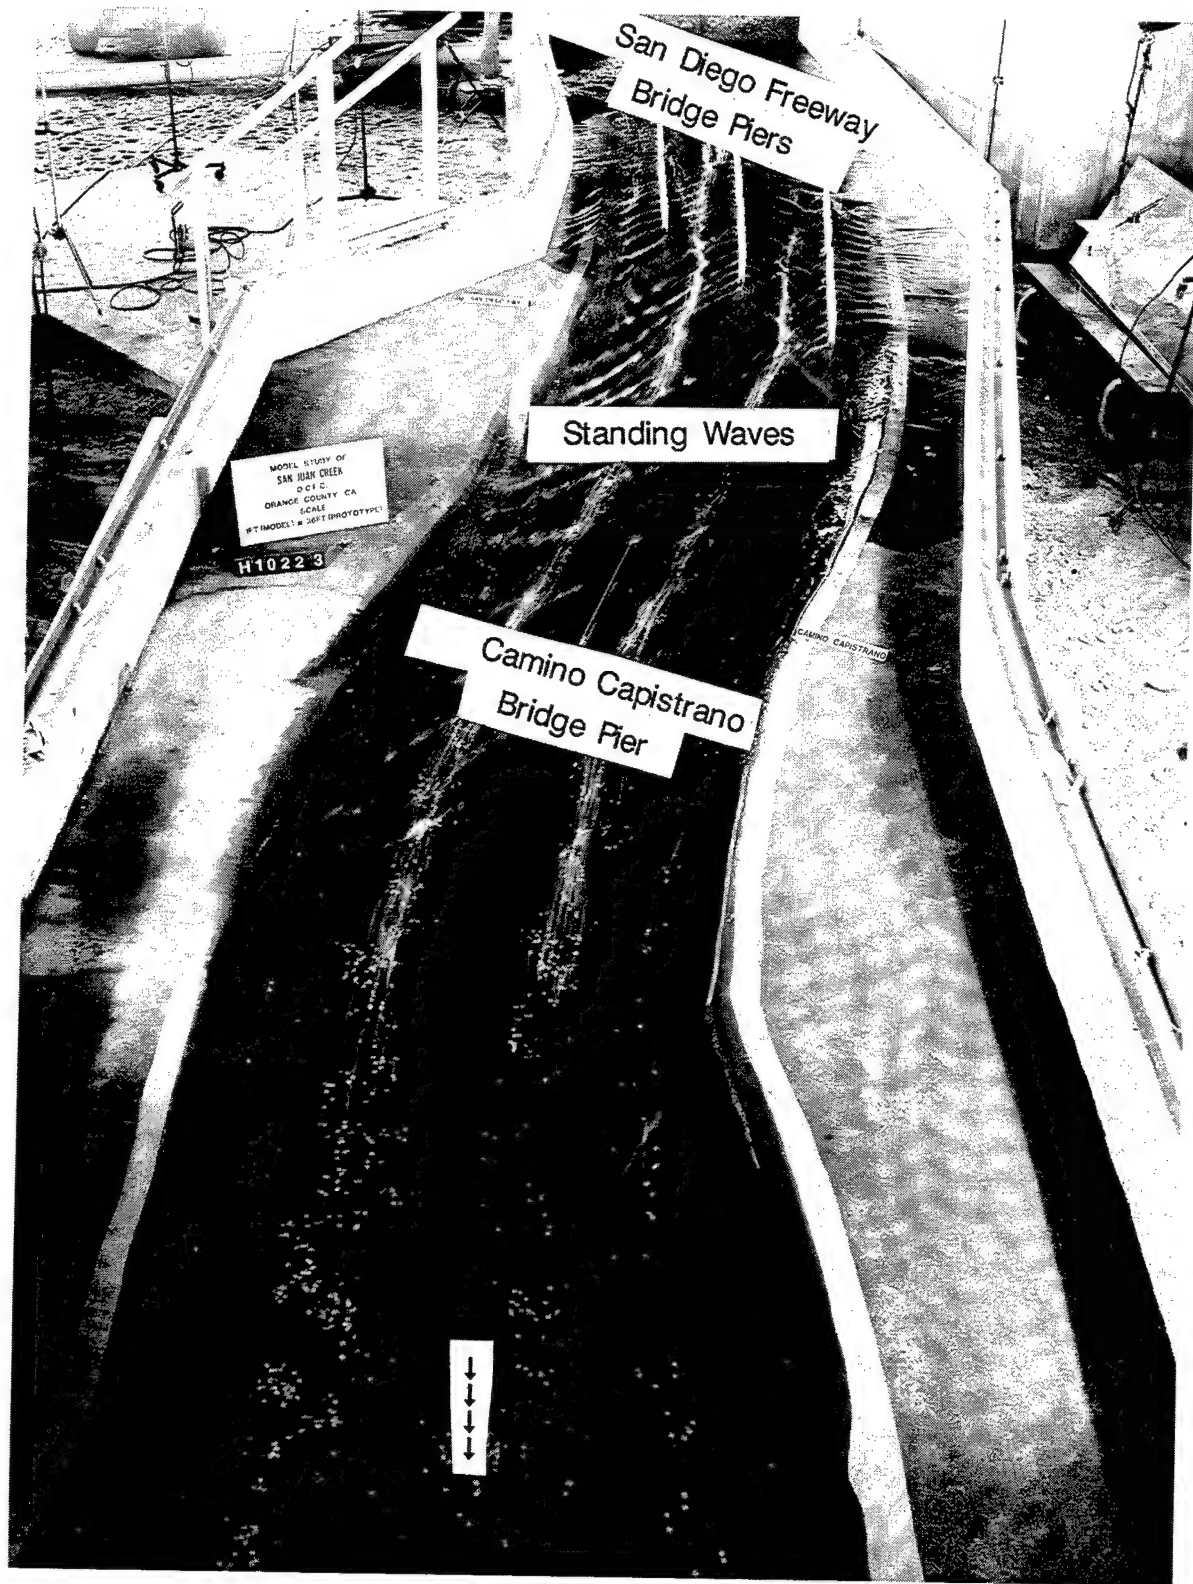
a. Design discharge,  $Q_{sj}$  42,000 cfs (1,176 cu m/sec)

Photo 2. San Juan Creek, type 1 design, oblique standing waves observed between the San Diego Freeway bridge piers (Sheet 1 of 3)

Standing waves created by the railroad bridge piers (Photo 4b) and oblique standing waves created by the San Diego Freeway bridge piers (Photo 2c) were observed downstream of the bridge piers. Oblique standing waves were also observed downstream of the grouted rock grade stabilizers (Photo 3c). A prominent oblique standing wave was observed in Trabuco Creek at the confluence and was caused by the access road and the nose of the confluence (Photo 5b). The access road on San Juan Creek upstream of the confluence also contributed to the standing waves downstream of the railroad bridge piers (Photo 4b).

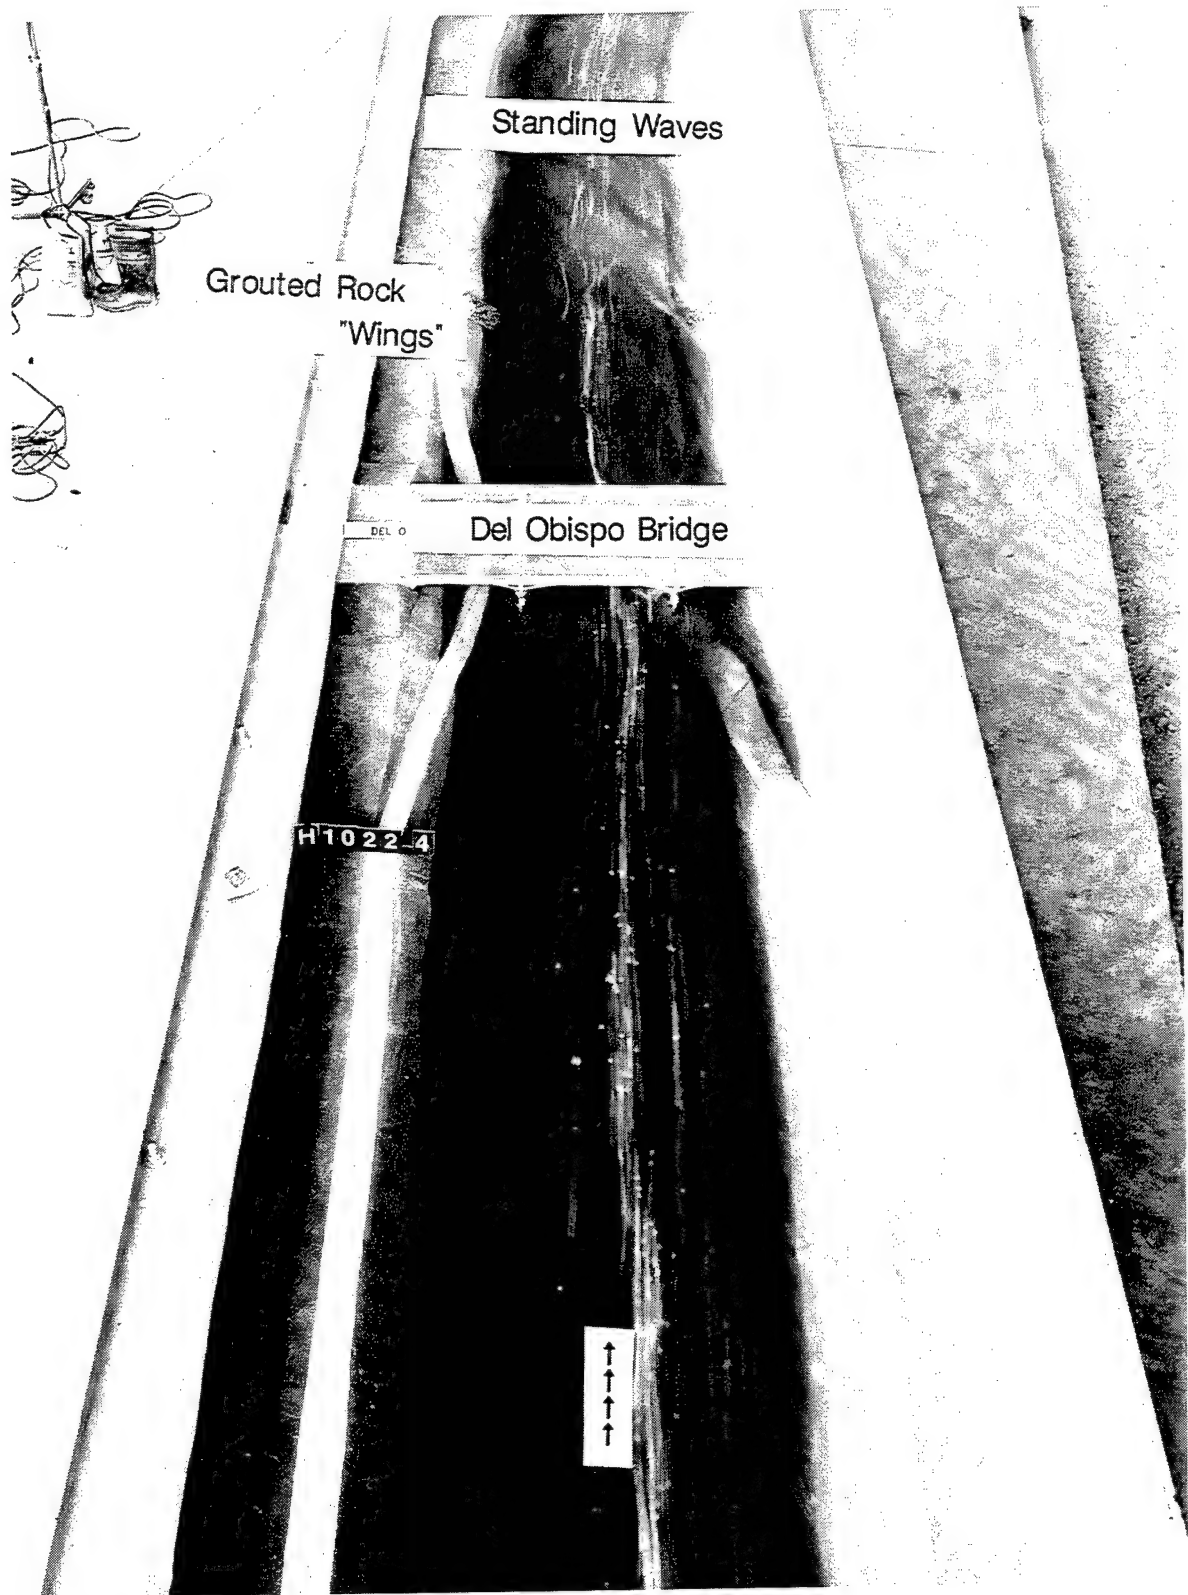
a. Design discharge,  $Q_{tr}$  17,000 cfs (476 cu m/sec)

Photo 3. Trabuco Creek, type 1 design, looking downstream at the Del Obispo Bridge. Oblique standing waves observed downstream of the grade stabilizer and created by the grouted rock wings. (Sheet 1 of 3)

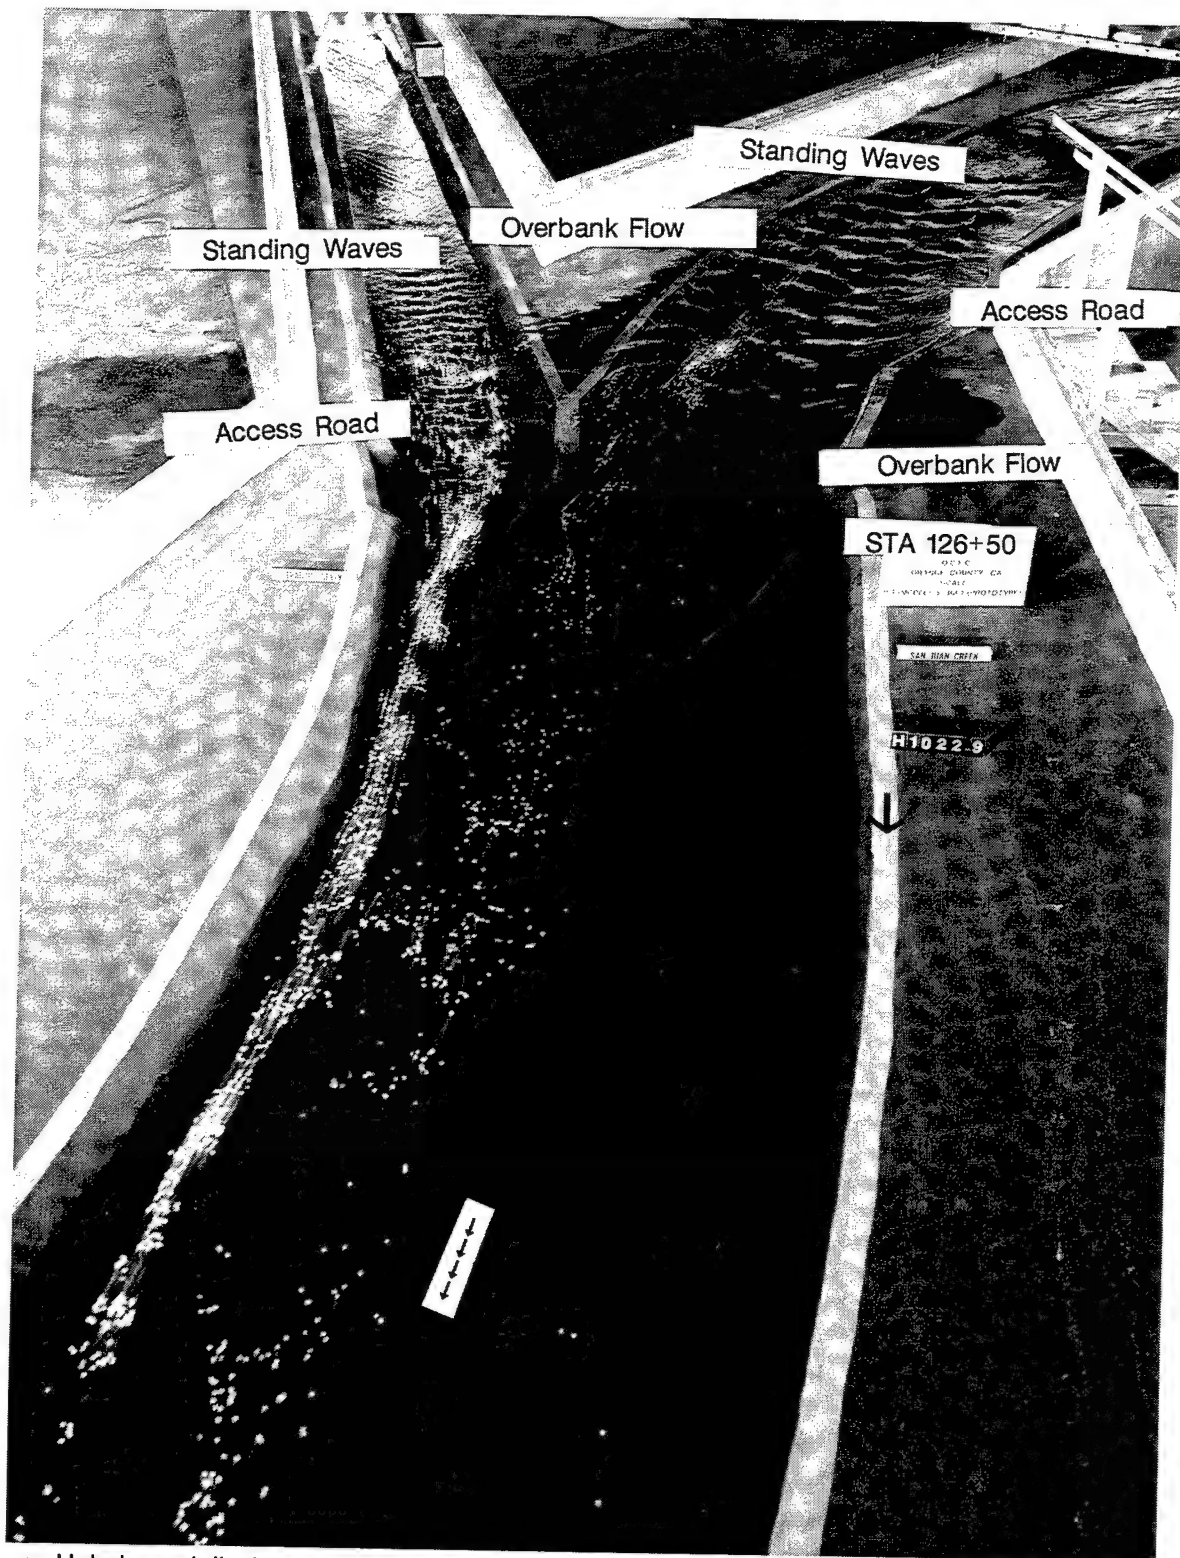
a. Unbalanced discharges,  $Q_{sj}$  35,000 cfs (980 cu m/sec) and  $Q_{tr}$  5,000 cfs (140 cu m/sec)

Photo 4. San Juan Creek, type 1 design, looking upstream at the confluence with Trabuco Creek. Standing waves observed downstream of railroad bridge piers, created by the bridge piers and access roads on San Juan and Trabuco Creeks. (Continued)

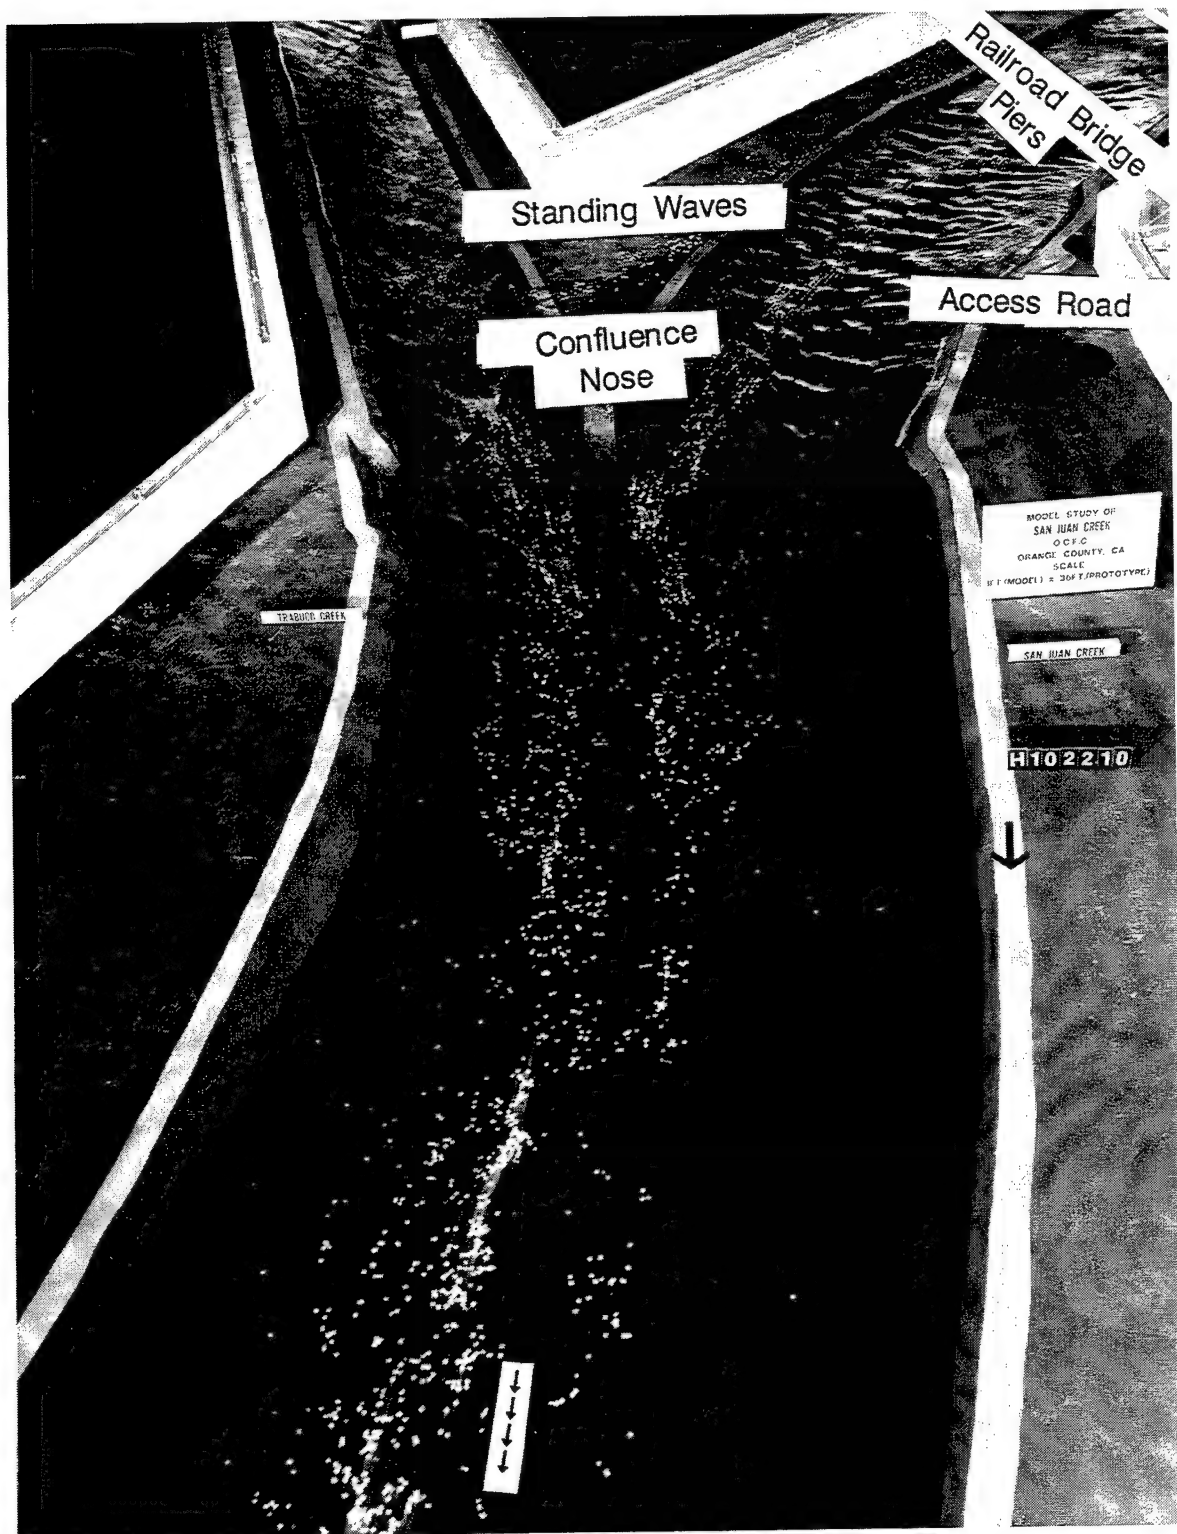
b. Balanced discharges,  $Q_{sj}$  17,000 cfs (476 cu m/sec) and  $Q_{tr}$  17,000 cfs (476 cu m/sec)

Photo 4. (Concluded)

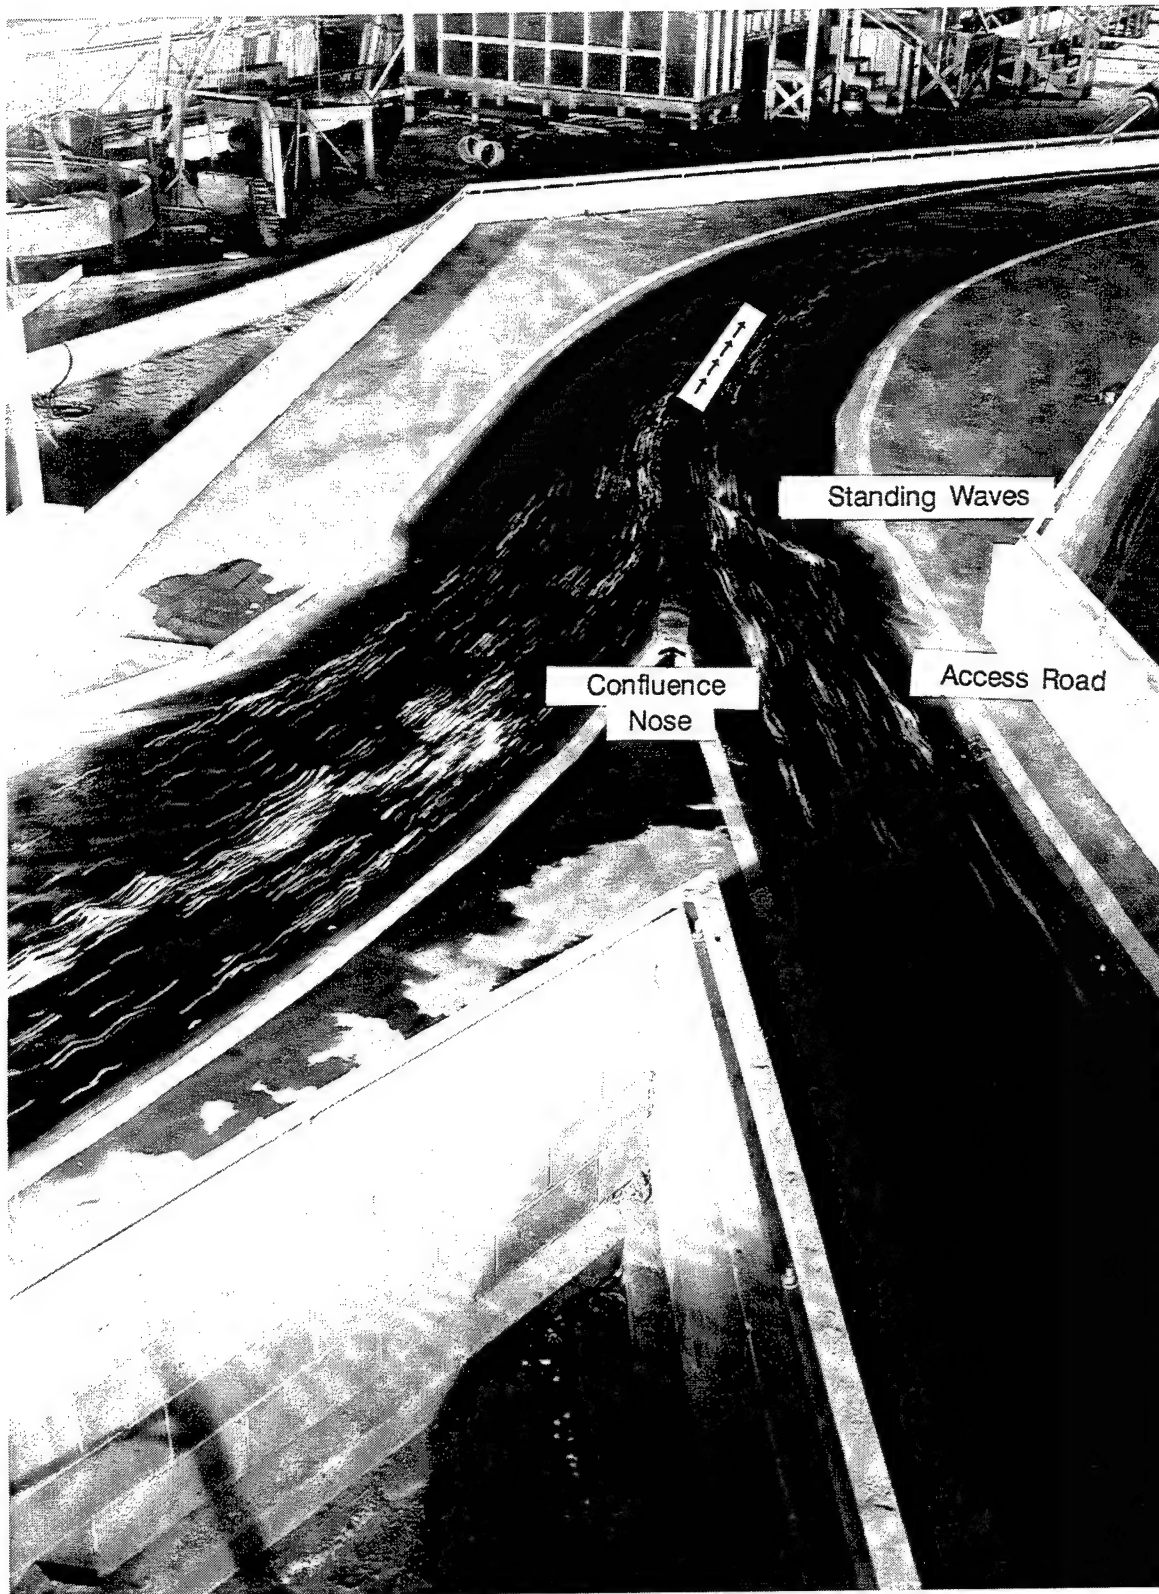
b. Balanced discharges,  $Q_{sj}$  17,000 cfs (476 cu m/sec) and  $Q_{tr}$  17,000 cfs (476 cu m/sec). Oblique standing wave observed in Trabuco Creek, created by access road and nose of confluence.

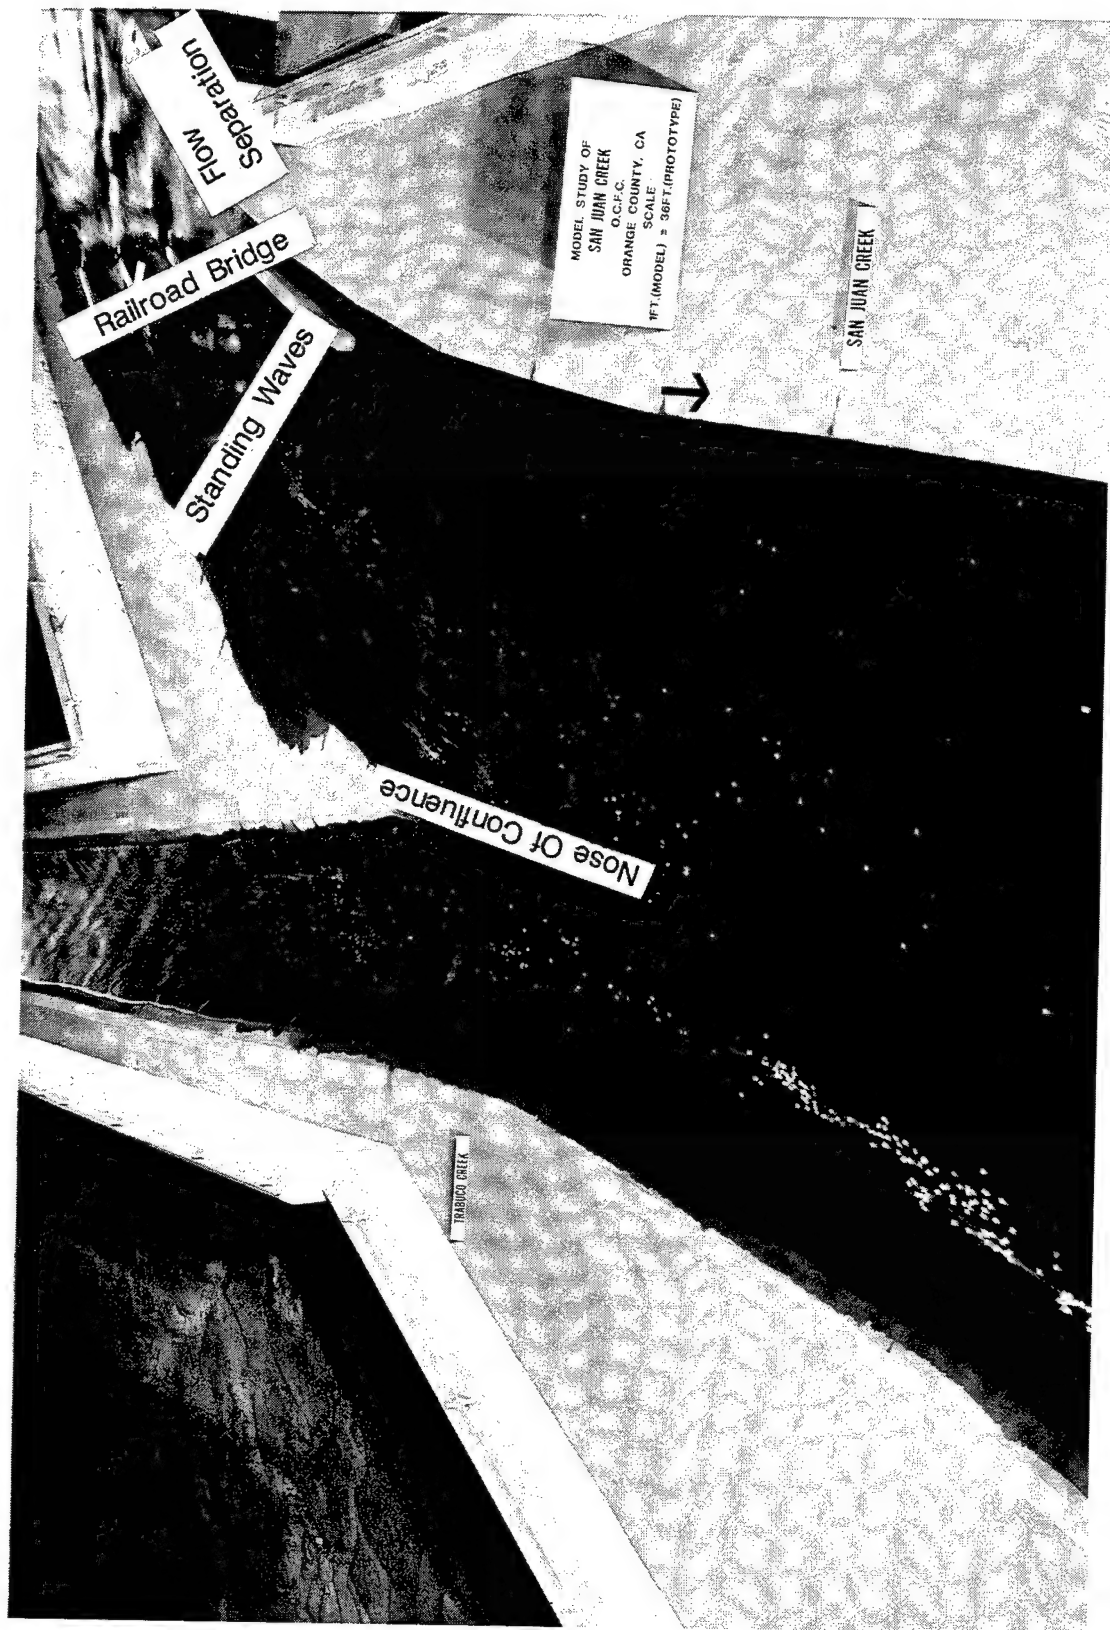
a. Design discharges,  $Q_{sj}$  42,000 cfs (1,176 cu m/sec) and  $Q_{tr}$  17,000 cfs (476 cu m/sec)

Photo 6. San Juan Creek, type 2 design, looking upstream at the confluence with Trabuco Creek. Standing waves observed were created by the railroad bridge piers. Flow separation observed on right bank forced flow toward left bank (Sheet 1 of 3)

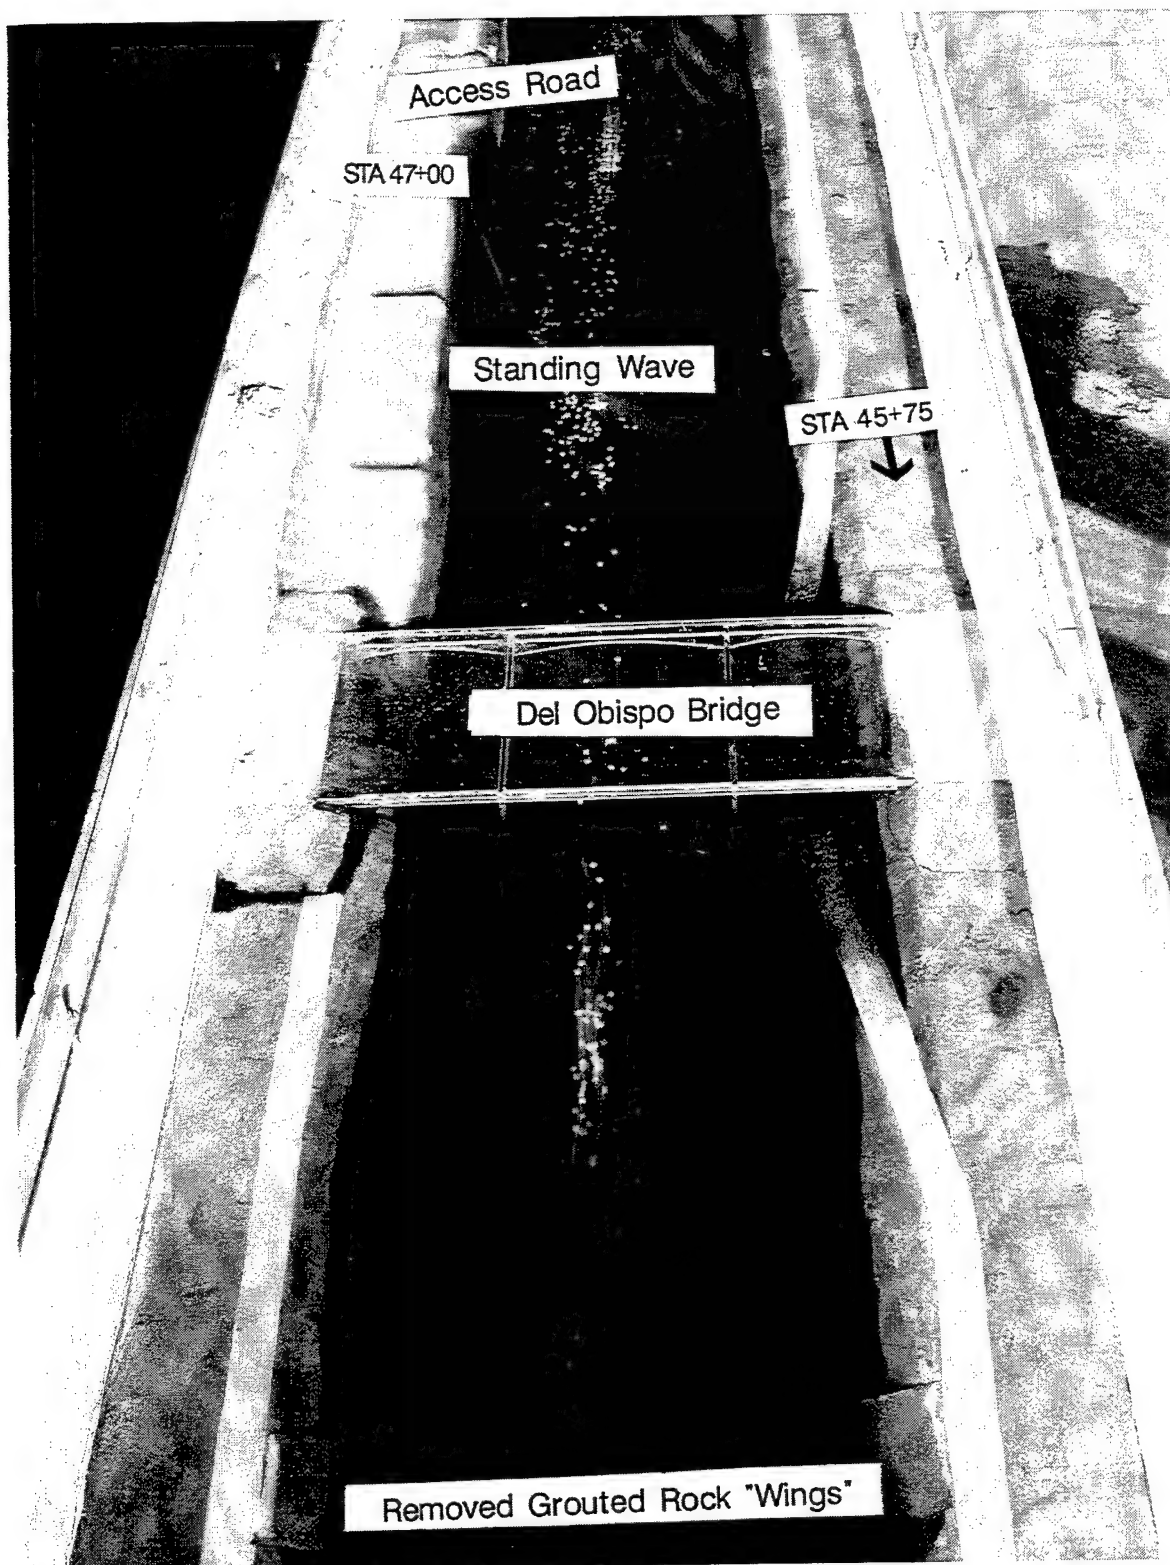
a. Design discharge,  $Q_{tr}$  17,000 cfs (476 cu m/sec)

Photo 7. Trabuco Creek, type 2 design, looking upstream at Del Obispo Bridge. The diagonal standing wave observed was created by the access road. Grouted rock wings were removed. (Sheet 1 of 3)

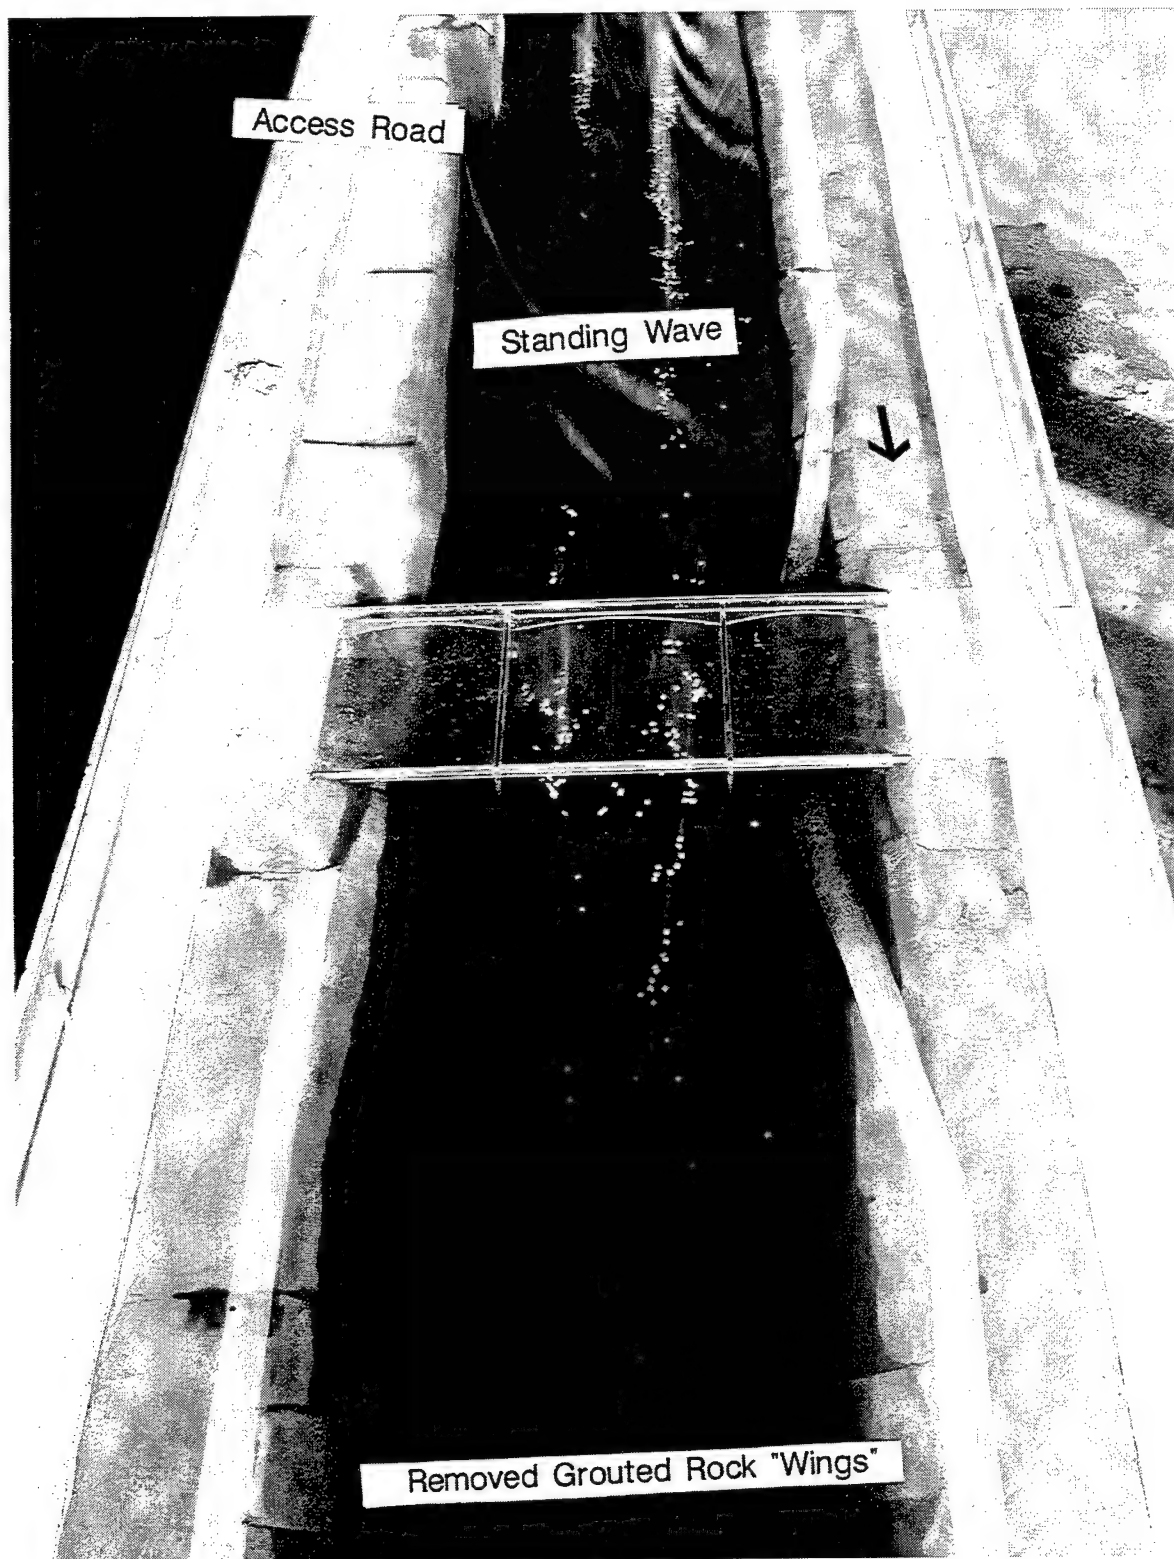
Photo 7. (Sheet 3 of 3)

c. Balanced discharge,  $Q_{tr}$  17,000 cfs (476 cu m/sec)

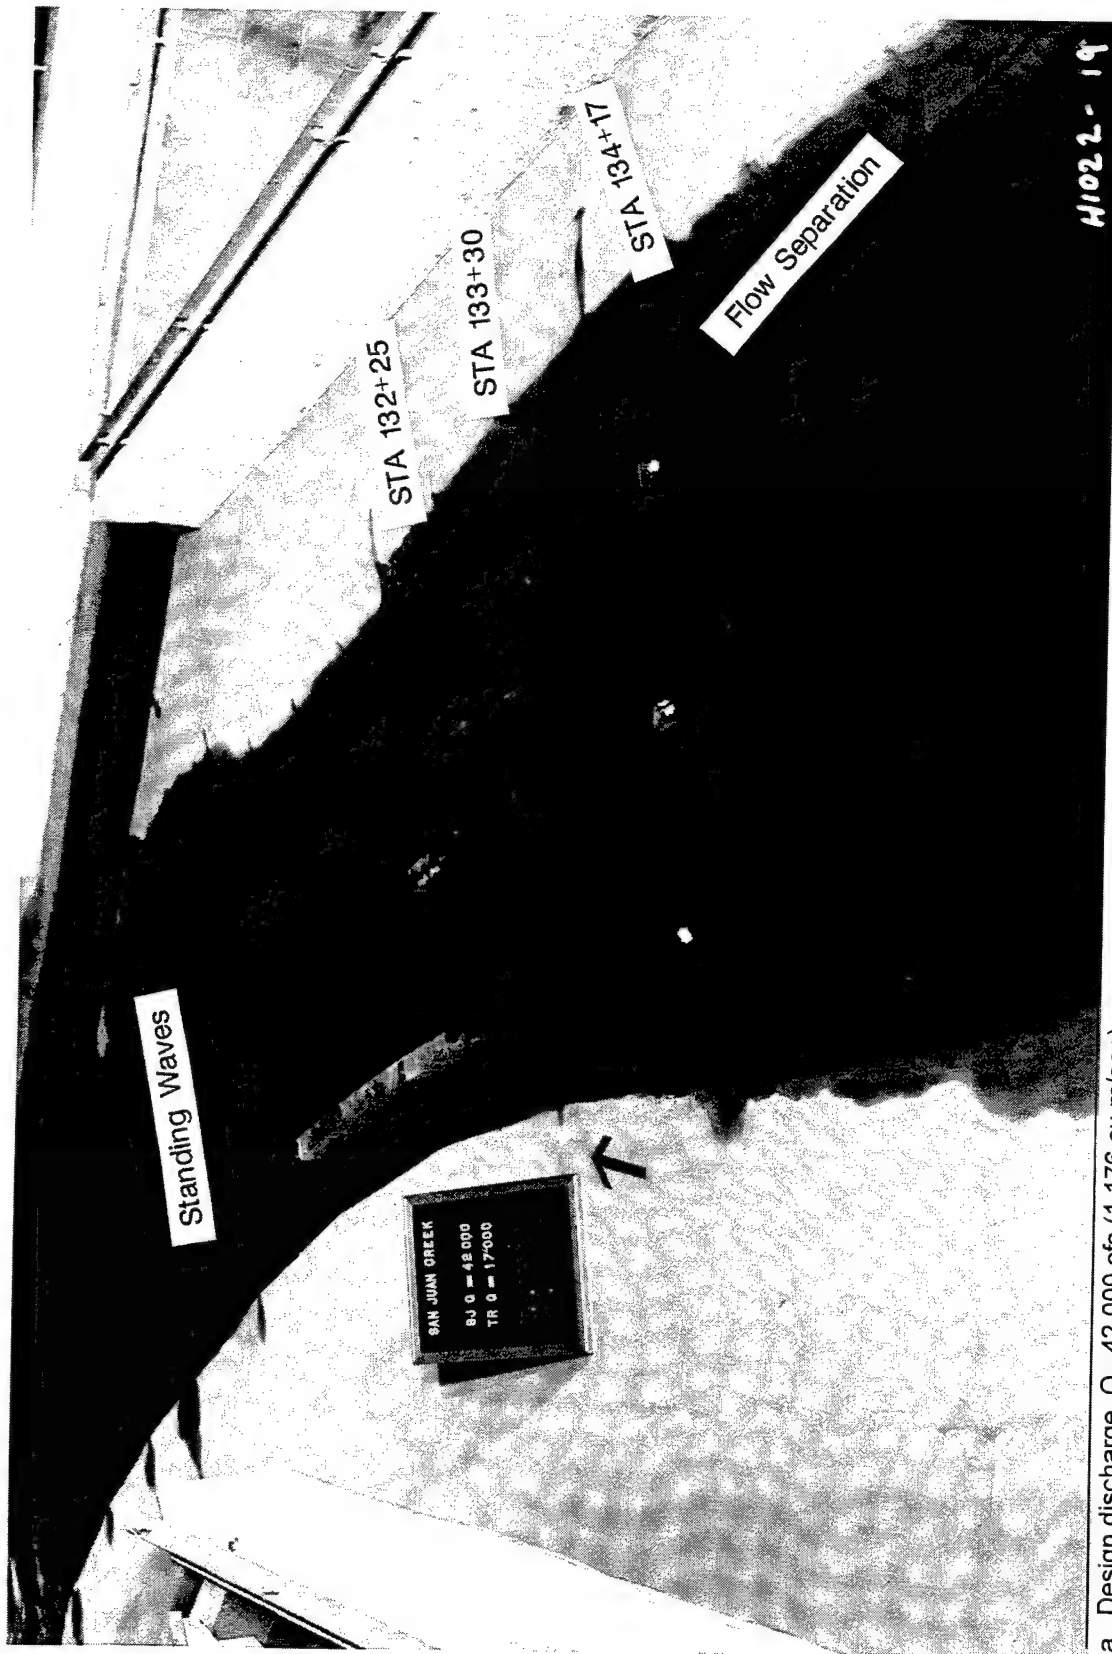
a. Design discharge,  $Q_{sj}$  42,000 cfs (1,176 cu m/sec)

Photo 8. San Juan Creek, type 6 design, flow conditions in the vicinity of the railroad bridge piers with pier extensions, downstream view. Flow separation observed on the right bank, created by the bike trail, contributed to standing waves downstream of the railroad bridge piers. A prominent standing wave extended the width of the channel, created by a decrease in the flow area.  
(Continued)

**Unbalanced discharges.** Various flow conditions for the unbalanced discharges (San Juan Creek 35,000 cfs (980 cu m/sec) and Trabuco Creek 5,000 cfs (140 cu m/sec)) for the type 6 design are shown in Photos 8b-10b. Standing waves were observed downstream of the railroad bridge piers (Photo 8b), and a prominent standing wave that extends the width of the channel was observed at sta 134+00 (Photo 8b). Flow separation was observed on the right bank at sta 134+50 and was created by the bike trail (Photo 8b). Flow conditions for the unbalanced discharges were better without the pier extensions.

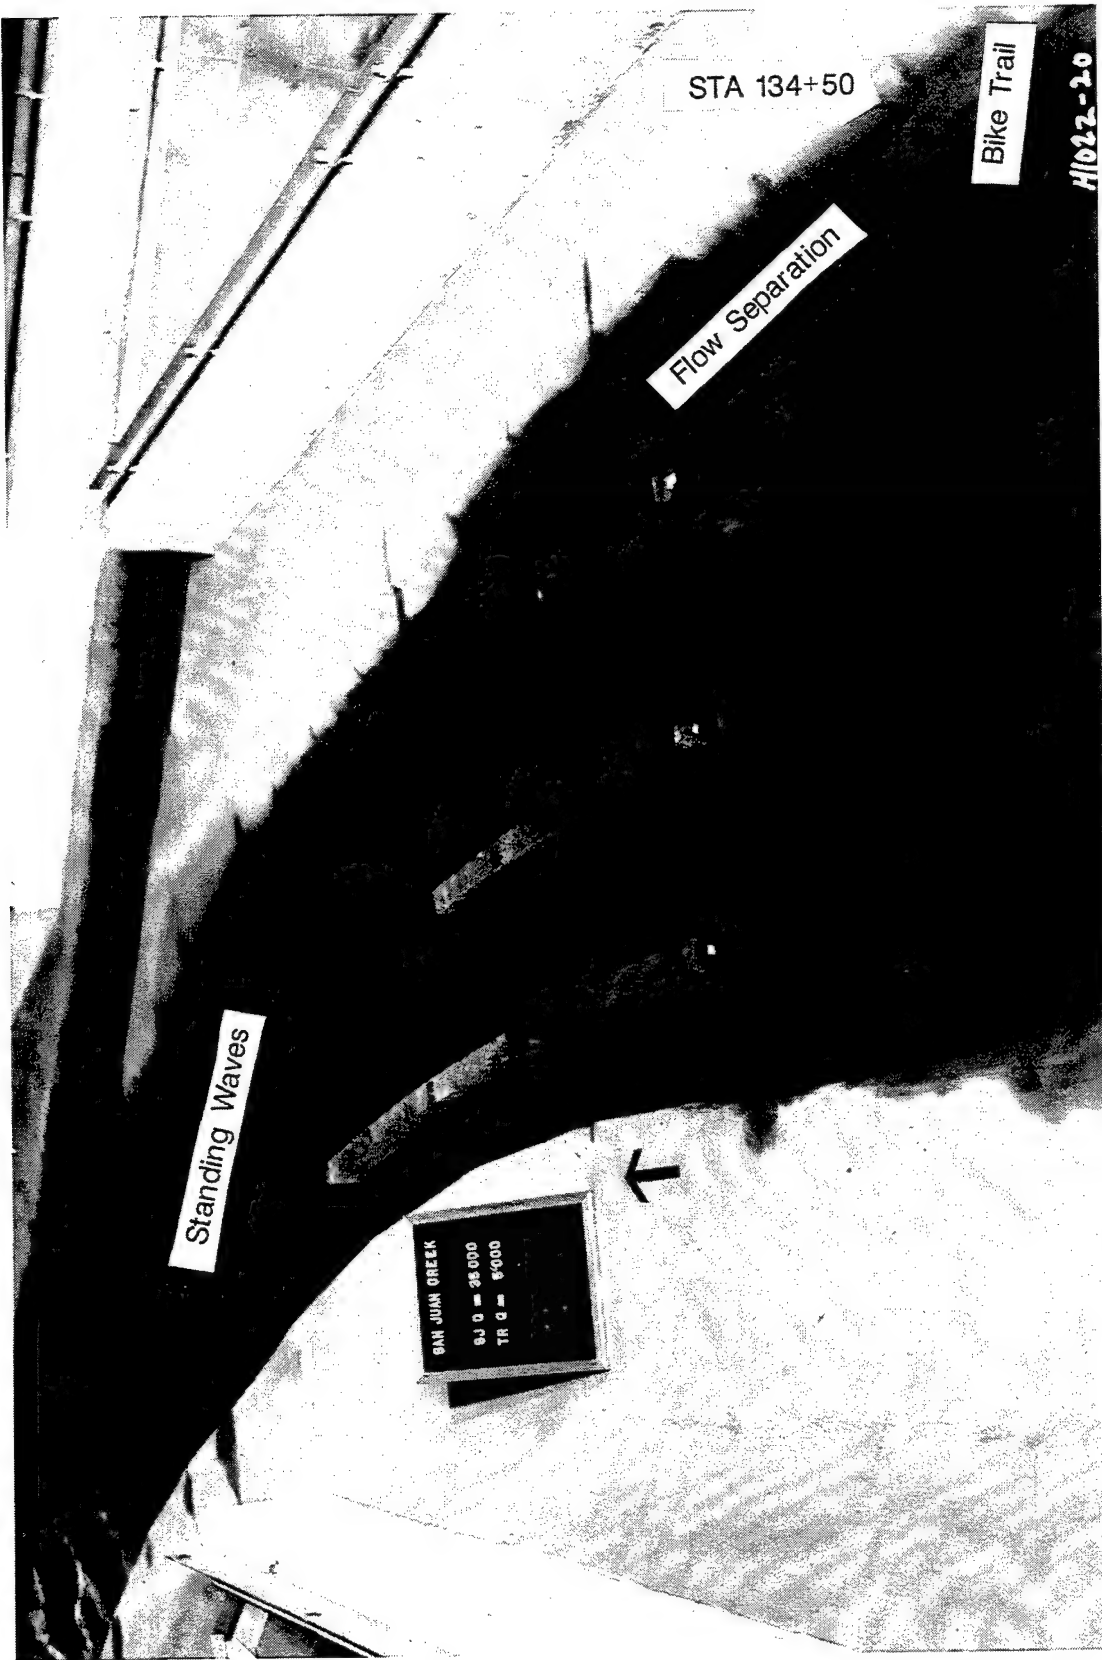
Photo 8. (Concluded)

b. Unbalanced discharge,  $Q_{sj}$  35,000 cfs (980 cu m/sec)
